Moreton Morrell Tennis Court Club

Post project report on court floor restoration

4th January 2021

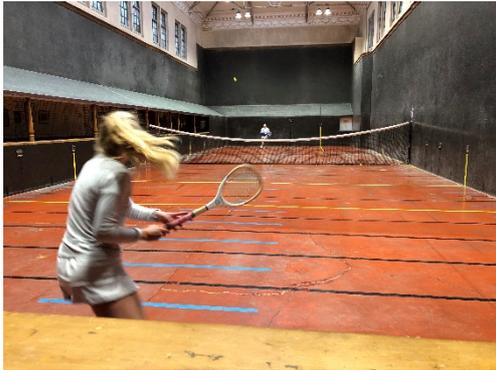
Bickley 1.0 floor 1905

Issues with the court floor had been worsening over the years including cracks, pock marked areas and steps at the slab joints. These were increasingly affecting the true bounce of the ball.

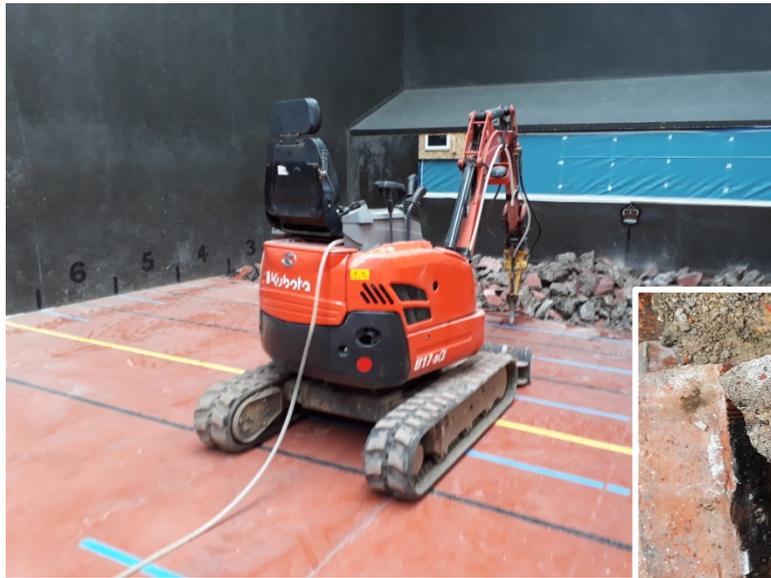
The demolition
Cross section of concrete

spoil was attractive high quality clean concrete useful for hardcore, and local disposal to other project works was cost neutral. Roughly 130 tonnes (16 truck loads) of concrete was removed. This was more than originally estimated as the floor depth varied from the core samples (see below).

- The Bickley concrete is about 200mm (8”) thick, sitting directly on a rammed granite chipping base, with no reinforcement and contains significant airholes, a range of gravel and appears wet from groundwater.
- Analysis of the surface by Dr John Murphy showed a very smooth surface compared to that of a modern gym, and one that would be unacceptably slippery when wet. Roughness was measured at <10 micron and texture typically -110 to -120 microns.

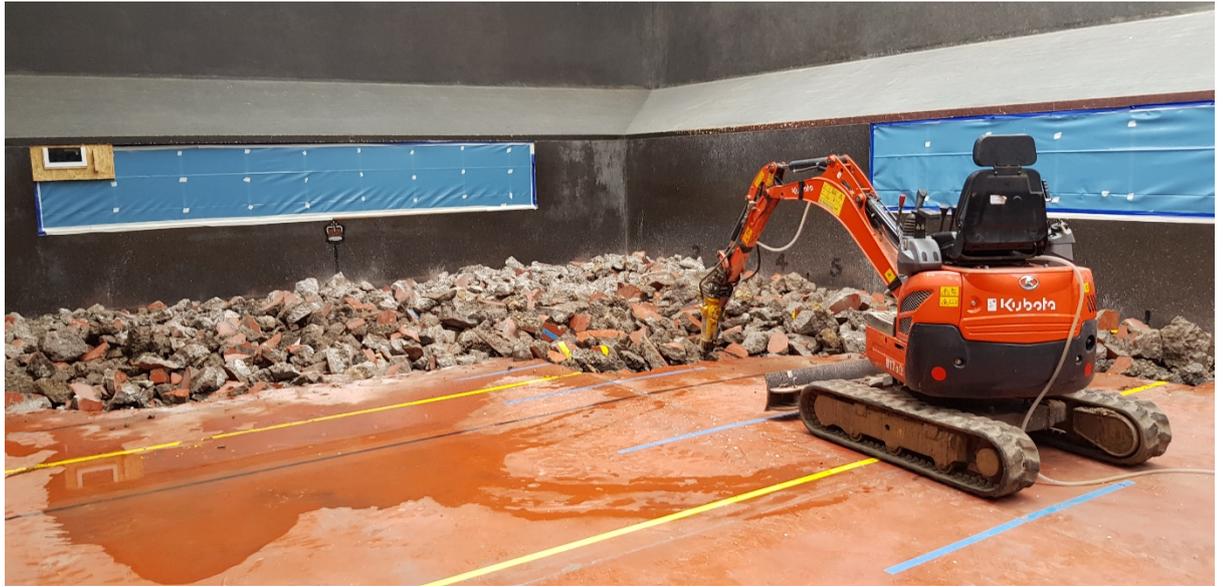
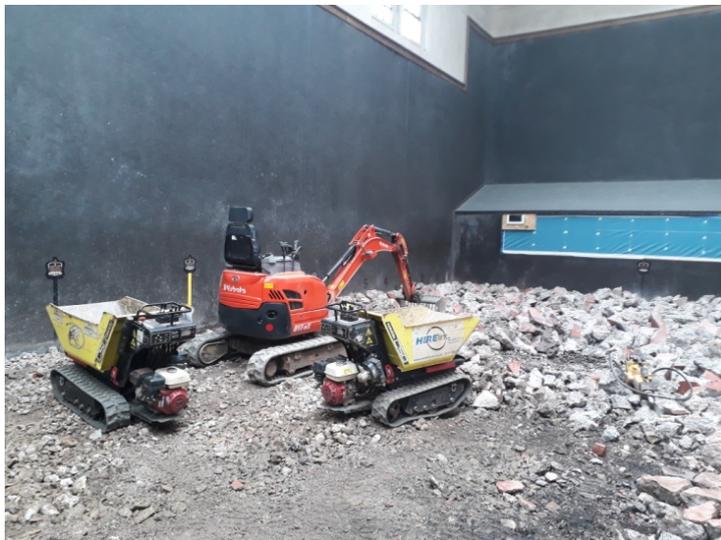
The levelling and preparation of the base

After the removal from the court of the broken concrete by motorised barrow, a range of smaller sized rubble was left in the court for the subsequent levelling work. We found that the service end of the court was indeed much as expected in thickness and level, but the receiving end was not. There the ground had not been well-levelled, crushed rock was sparse and indeed the concrete was up to 24" (600mm) thick in places. In particular, the area in front of the tambour had two large clay boulders protruding from the surround and bare of crushed rock. We speculated that these had caused the old floor to crack significantly about 40 years ago, when they swelled in high water table conditions. (About 30 years ago, the bank outside the main wall had been dug back, probably modifying the water table and preventing further damage). All the floor and in particular the receiving end was worked to level the soil, fill voids with suitably broken recycled concrete, and using the more finely crushed rubble to consolidate to a suitable level throughout.

What was found under the old floor, particularly near the tambour, indicates that original poor ground levelling may well have left causes of stress and hence the floor slab fracture which was observed around 40 years ago.
